UTAH AIR QUALITY BOARD MEETING

DRAFT AGENDA

Wednesday, December 6, 2006
1:30 p.m.

**AN ASBESTOS SURVEY AND ASSESSMENT
FOR THE
DESERET TOWERS "W" HALL
BRIGHAM YOUNG UNIVERSITY
PROVO, UTAH**

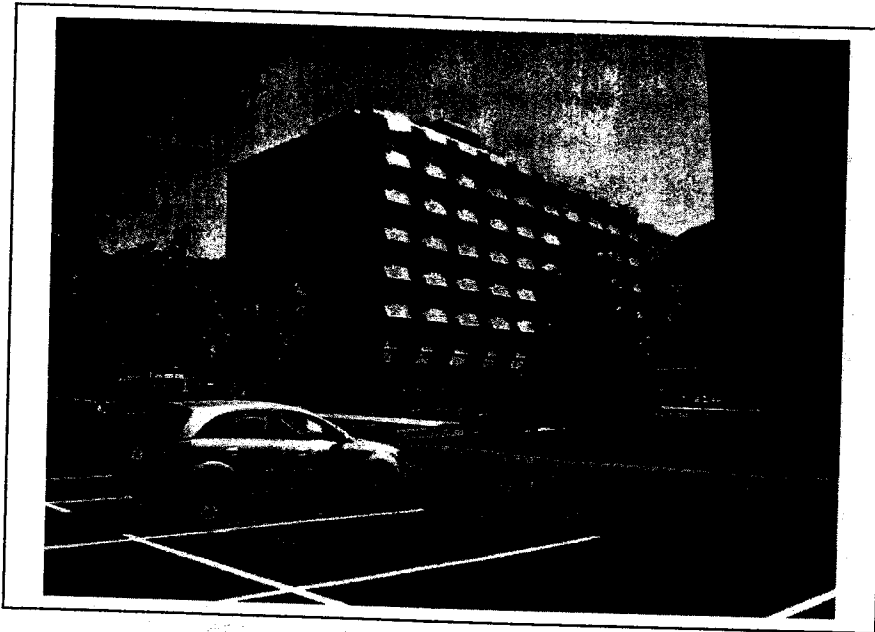
PHOTO 1

- 1. Exterior view of building looking Noutheast**
- 2. Textured ceiling material throughout the building contains asbestos**
- 3. Vinyl floor tile on stairway landings contains asbestos**
- 4. Sink undercoating in the ironing room area contains asbestos**
- 5. Sink undercoating in the first floor manager's residence contains asbestos**
- 6. Thermal System Insulation mudded fittings throughout the building contains asbestos**
- 7. Thermal System Insulation mudded fittings throughout the building contains asbestos**
- 8. Thermal System Insulation mudded fittings throughout the building contains asbestos**
